ScaleBuster – maintenance-free operational service for over 15 years

Phoenix Student residences; The University of Brighton

To investigate the useful service life of a ScaleBuster unit that had been in active use for in excess of 15 years. This was done through the comparison of the unit with the original specification of the unit when it was manufactured.

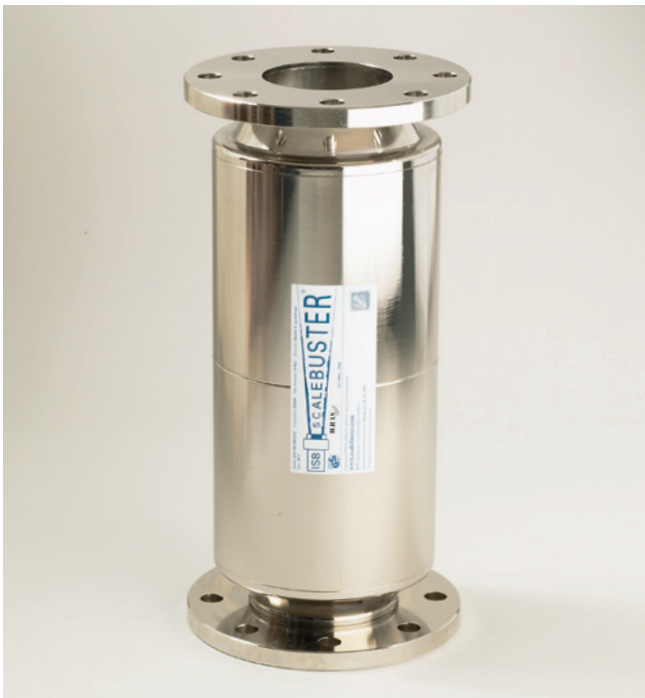
Complete details of the unit removed and inspected

Serial Number:	6792
Size:	DN100 8-off holes 18mm Dia on 210 P.C.D.
Model:	F100 2nd Generation
Flange:	ISO PN10 – (type 21)
Material Construction:	Brass Body, Nickel Plated
Materials used:	Brass Body, Zinc Anode, PTFE fin design
External Max Dimensions:	L375mm x W250mm
Supplied:	25/7/1996
Age:	15 years 5 months

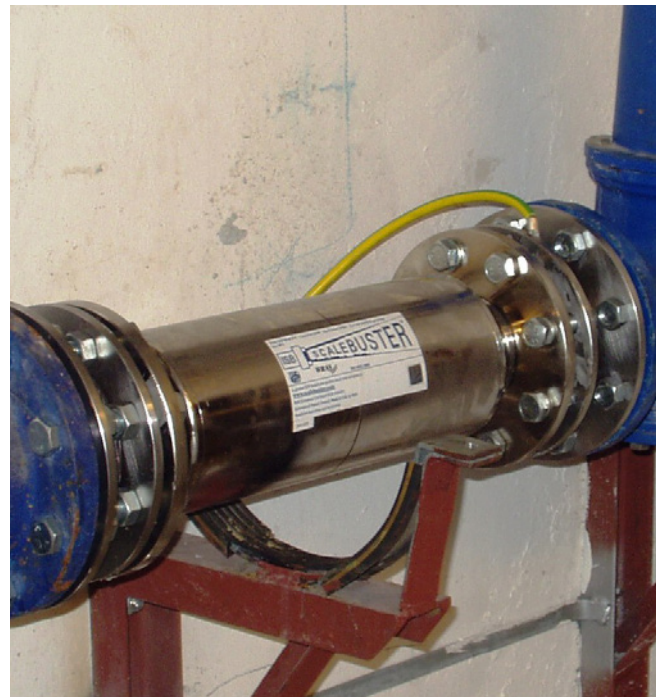
External inspection showed the body of the unit to be in good order. The nickel plating was in good condition and there was no corrosion or pitting of the brass.

The central spindle and all PTFE fins were in good order. All Fins were present and were tight within their housing indicating that minimal reduction in the anode had taken place.

Internal inspection of the body and anode revealed that internal bore of the brass body of the ISB was found to be in good condition and no corrosion of the brass body was evident.

The ISB F100 removed was a second generation unit with a single zinc anode which was changed to two anodes in later models. The zinc anode was removed from the body and then weighed and measured. This was then compared to the original specifications of the zinc anode in the original second generation units. The dimensions and weight of the anode that had been in service for over 15 years was still within the original manufacturing tolerances of the unit when it was manufactured in 1996.
