# ScaleBuster – maintenance-free operational service for over 15 years

James Hornsby School, Basildon, Essex

To investigate the useful service life of three different sized ScaleBuster units that had been in use within the school for a period in excess of 15 years. To assess how the water treated by the use of ScaleBusters had affected the calorifiers within the system.

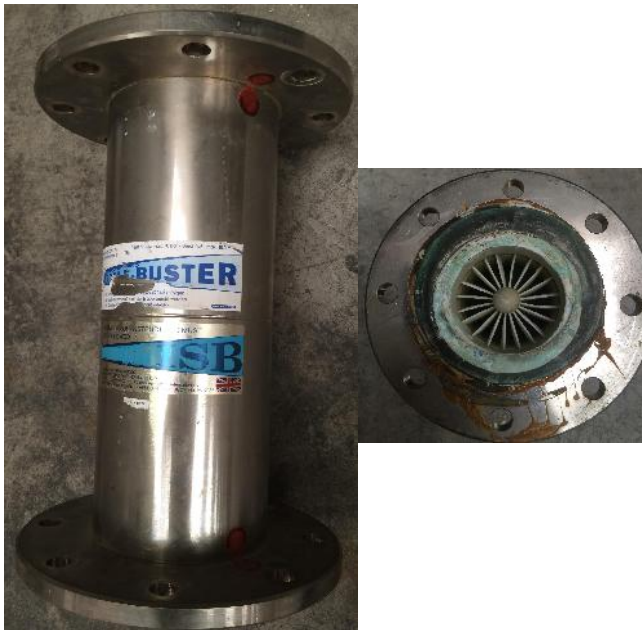
ScaleBuster DN75 - serial number 014805  
- 2nd generation fin design

External inspection showed the body of the units to be in good order. The nickel plating was in good condition and there was no corrosion or pitting of the brass.

The central spindle and all PTFE fins were in good order on the flanged units. All fins were present and were tight within their housing indicating that minimal reduction in the anode had taken place.

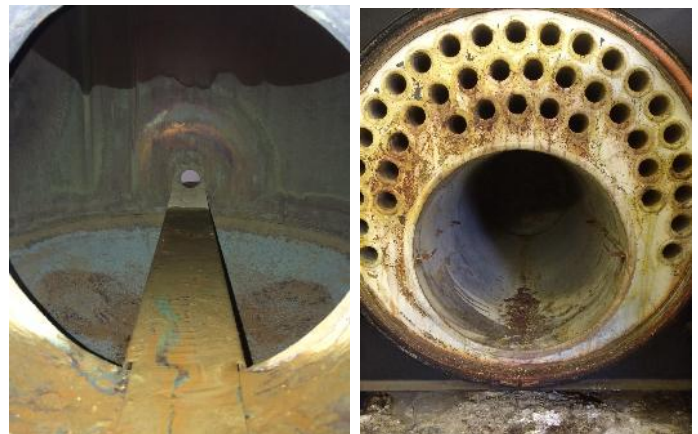
The contractor involved in the replacement of the calorifiers took pictures of the inside of the existing calorifiers before they were removed (see opposite). The images show no build up of scale on either the cylinder walls or the heat exchange walls.

Based on this evidence the ScaleBusters had performed their function of preventing the build up of hard scale within the calorifiers during their operational life.

Internal images of the calorifiers prior to removal
