## HIGH PERFORMANCE KEY VALVE TESTING RESULTS

**TEST REPORT 17.02.2016**

**FALCON REPORT NUMBER RE160217\_HP KV001**

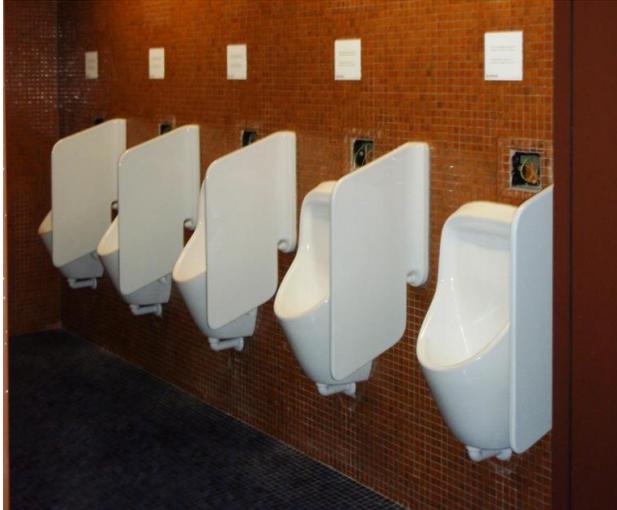
## INSTALLATION TESTING LOCATION:

**INSTALLATION:** 5 Urinals (Model 7000), 50 mm drain hole size in the bowl, Key-Adapter SE000 (long) installed (same size as SE037, Ideal Standard).

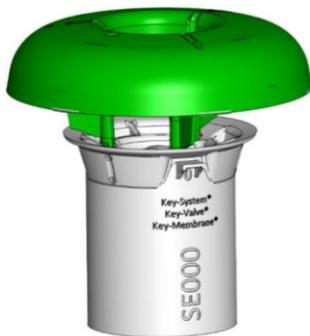
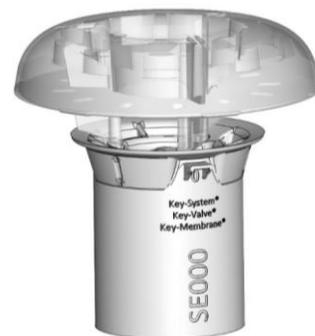
The Key-Ring is an indicator which shows when the valve has to be changed. After approx. 7500 uses the Key-Ring mass completely dissolves, signaling it is time to change the valve.

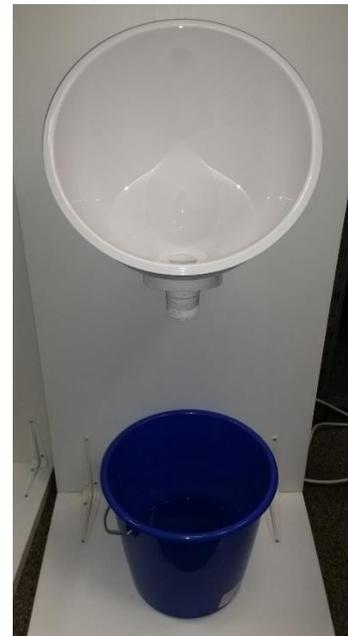
Five (5) HPKV units were tested for flow rate, with the water volumes noted above, in a standardized bowl (Key-One, see picture on the right). For comparison, the same procedure was followed with our existing Key-Valve and competitor mechanical valves, including: Whiffaway, Urimat and Helvex.

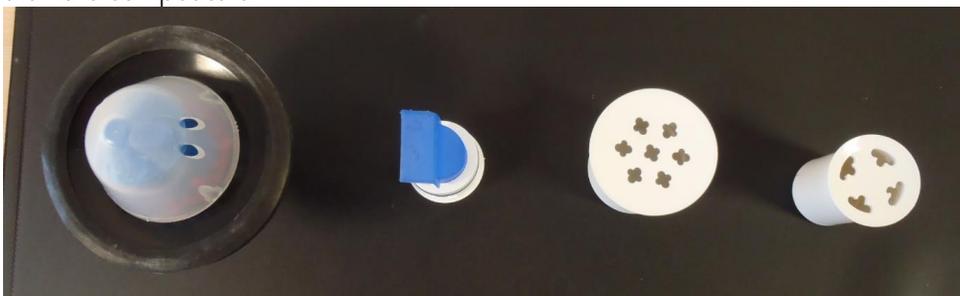
From left to right: Urimat, Whiffaway, large Helvex and small Helvex.

Flow rate was tested to show about half of that of the HPKV. Furthermore, the bended tube valve is very prone to sticking. When we initially tested the valves, the flaps stuck to each other and drainage time of 250 ml was longer than 30 seconds. In addition the pressed tube structure with the bend in the middle section of the membrane proved difficult to flush out common debris.
