ScaleBuster – maintenance-free operational service for over 15 years

Phoenix Student residences; The University of Brighton

To investigate the useful service life of a ScaleBuster unit that had been in active use for in excess of 15 years. This was done through the comparison of the unit with the original specification of the unit when it was manufactured.

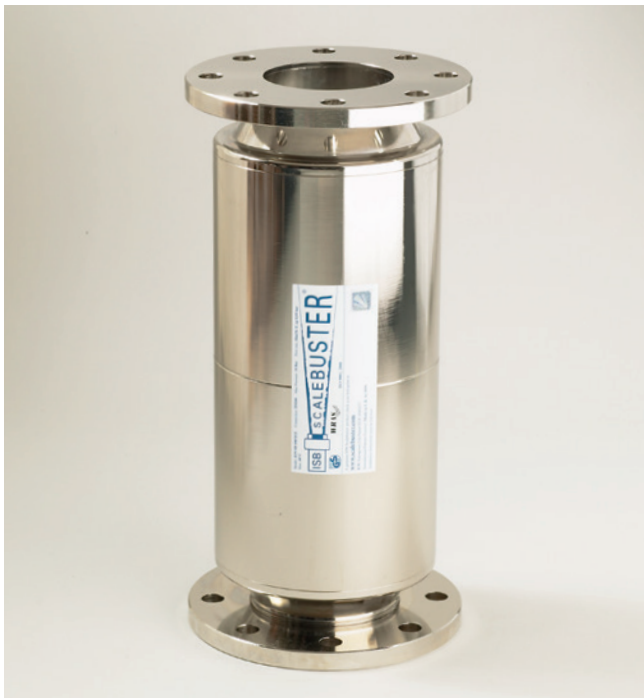
Complete details of the unit removed and inspected

Serial Number:	6792
Size:	DN100 8-off holes 18mm Dia on 210 P.C.D.
Model:	F100 2nd Generation
Flange:	ISO PN10 – (type 21)
Material Construction:	Brass Body, Nickel Plated
Materials used:	Brass Body, Zinc Anode, PTFE fin design
External Max Dimensions:	L375mm x W250mm
Age:	15 years 5 months

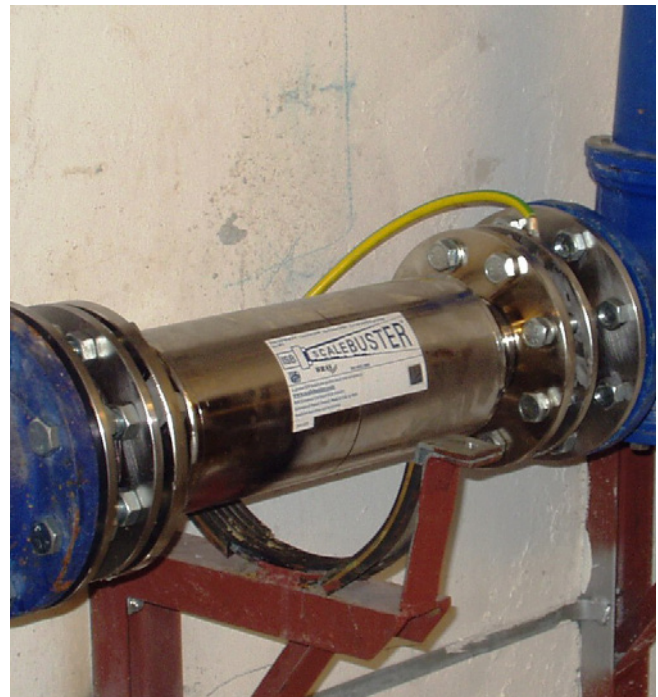
External inspection showed the body of the unit to be in good order. The nickel plating was in good condition and there was no corrosion or pitting of the brass.

The central spindle and all PTFE fins were in good order. All Fins were present and were tight within their housing indicating that minimal reduction in the anode had taken place.

Internal inspection of the body and anode revealed that internal bore of the brass body of the ISB was found to be in good condition and no corrosion of the brass body was evident.

The ISB F100 removed was a second generation unit with a single zinc anode which was changed to two anodes in later models. The zinc anode was removed from the body and then weighed and measured. This was then compared to the original specifications of the zinc anode in the original second generation units. The dimensions and weight of the anode that had been in service for over 15 years was still within the original manufacturing tolerances of the unit when it was manufactured.
